**SUSQUEHANNA RIVER BASIN**  
**BROAD CREEK, HARFORD COUNTY**  
**MARYLAND**

# **BROAD CREEK DAM**

**NDI NO. MD 00017**

## **PHASE I INSPECTION REPORT**

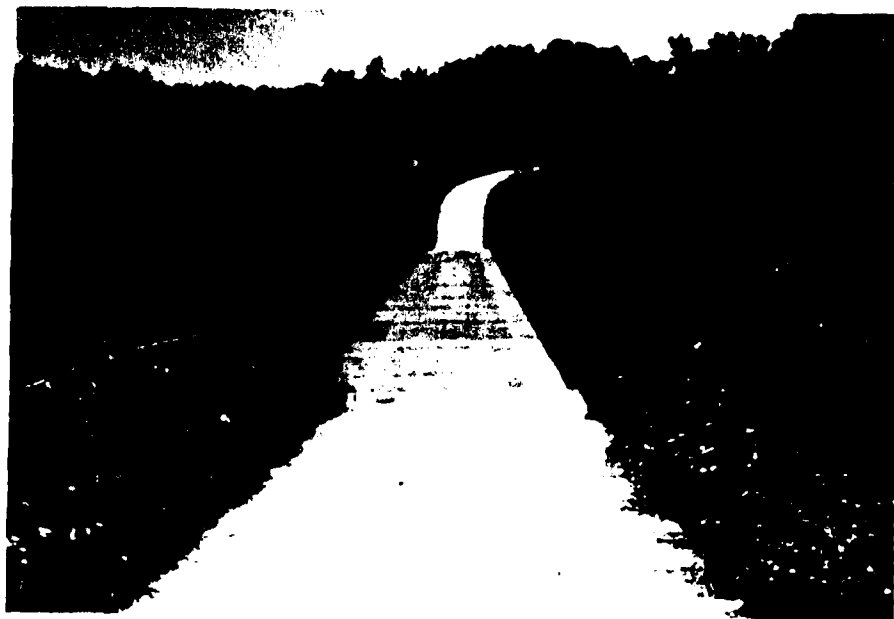
1. The embankment is limited to abutment areas and appears uniform and stable with no indication of cracking, settlement of differential movement.
2. Loss of vegetative cover and minor erosion due to foot traffic was observed on the downstream face of each abutment embankment. At the downstream toe of the embankment at the right abutment, measureable erosion gullies have formed due to concentrated surface runoff from adjacent roadways.
3. Woody vegetation was observed on all the embankment slopes.

DAM CREST

a. Embankment. The footpaths and minor erosion on the downstream faces of the abutment embankments could provide preferential flow paths and serious erosion in the event of overtopping. These areas should be stabilized with vegetation and foot traffic discouraged. The gully at the downstream toe of the right abutment embankment should be repaired and stabilized by controlling the surface runoff from the road areas. Woody vegetation on the embankment slopes should be removed.

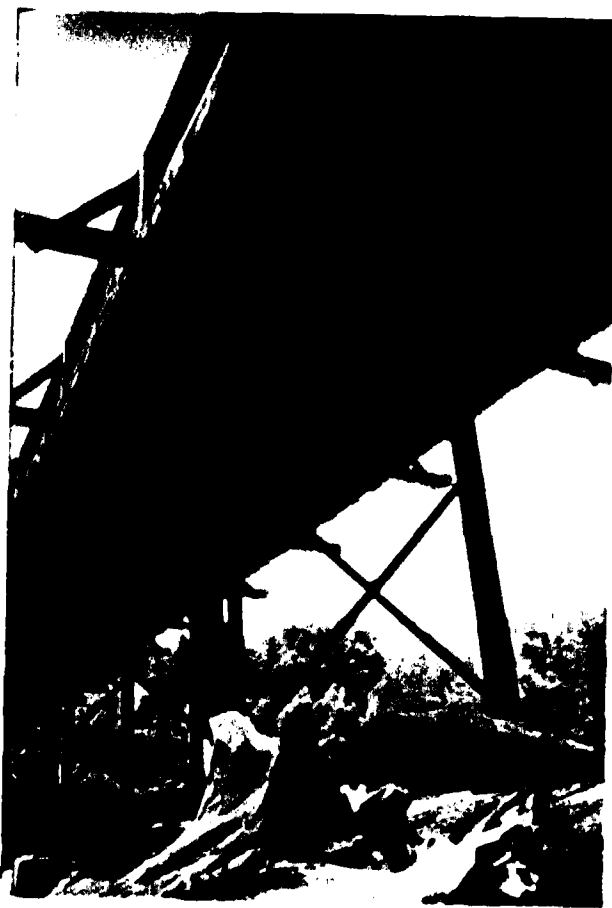
VISUAL EXAMINATION OF	OBSERVATIONS AND REMARKS/RECOMMENDATIONS
CONCRETE WEIR	See Concrete/Masonry Dams
APPROACH CHANNEL	N/A
DISCHARGE CHANNEL	Natural stream channel
BRIDGE AND PIERS	Bridge and piers over spillway in good condition. Bridge appears not to have been constructed according to any accepted design standard.

BRIDGE OVER  
SPILLWAY

c. Appurtenant Structures. The leak in the drain opening sluice gate should not affect the stability of the dam at this time. The gate, however, should be repaired to ensure continued good operation. According to the design plans in Appendix C, the bridge over the spillway was designed for a 5 ton truck and the structure should be appropriately posted to prevent loss of both the bridge and spillway capacity.

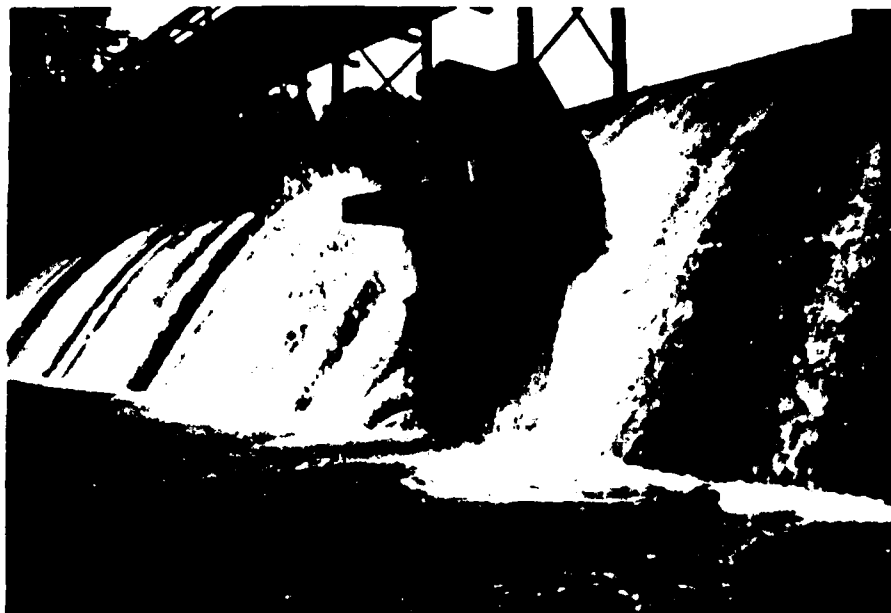
2. The concrete surface of the ogee spillway was in good overall condition, but numerous spalls, 2 to 5 inches in depth, were detected on the lower portion of the spillway at construction joints.

1. The drain opening sluice gate on the left side of the ogee spillway section leaks considerably due to improper seating of the gate. Although the gate operation was not demonstrated during the field inspection, the reservoir was drained within the past year and the gate is assumed to be functional. Access to the gate control is by boat and during periods of heavy spillway discharge, operation of the gate will not be possible.
2. The bridge structure over the spillway appears to be in good condition. Judging from the relatively light structural members, the bridge has a low capacity but no weight limits were posted.

SPILLWAY FACE &  
DRAIN OUTLET

b. Overflow Spillway. Although the spalls in the ogee spillway face do not presently affect the stability of the structure, they should be repaired to prevent accelerated deterioration of the concrete. The open construction joint on the left side of the spillway apparently extends through the dam to the silt laden pool water. The stability analyses in Section 6 and Appendix E, however, suggest that the effect of the open joint upon stability is negligible. The debris accumulated on the spillway should be removed to maintain maximum available flow capacity.

4. Repair the spalled concrete on the overflow spillway face.
5. Repair the leak in the sluice gate for the reservoir drain.
6. Remove timber debris from the spillway.
7. Post weight limit on the bridge over the spillway.

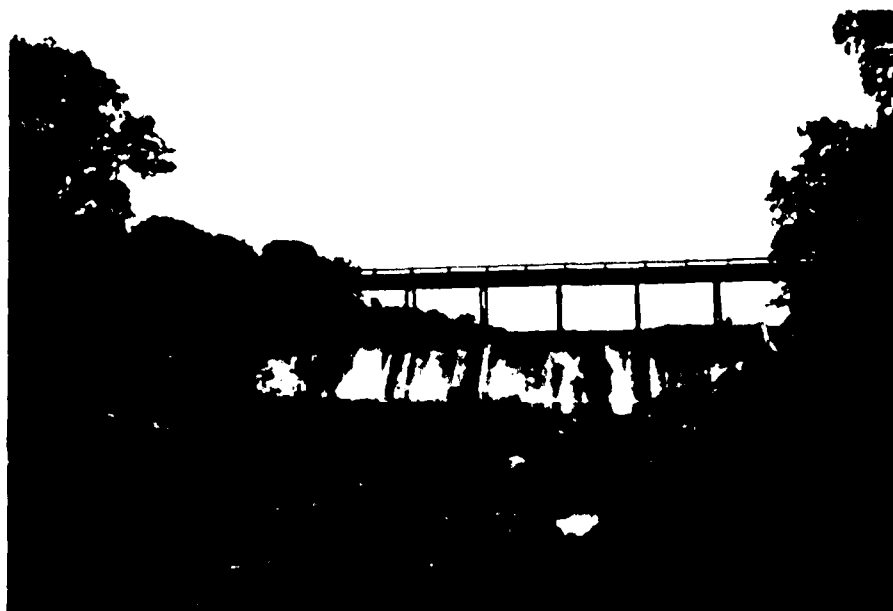
DOWNSTREAM VIEW

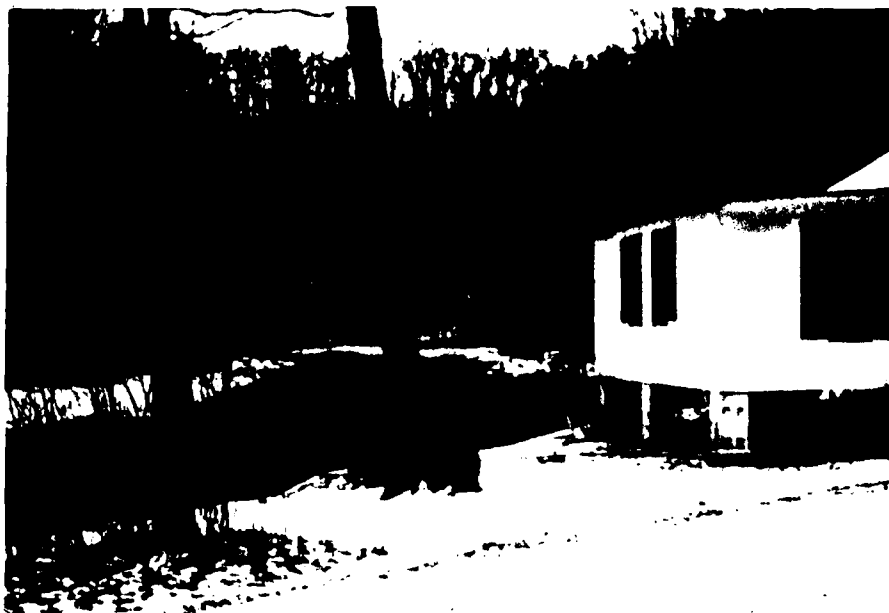
f. Downstream Conditions. As previously discussed in Section 3, damages to downstream dwellings and a State road are likely in the event of complete dam failure. Due to the concentration of dwellings along the stream banks loss of life is probable.

DWELLINGS  
2500 FEET DOWNSTREAM

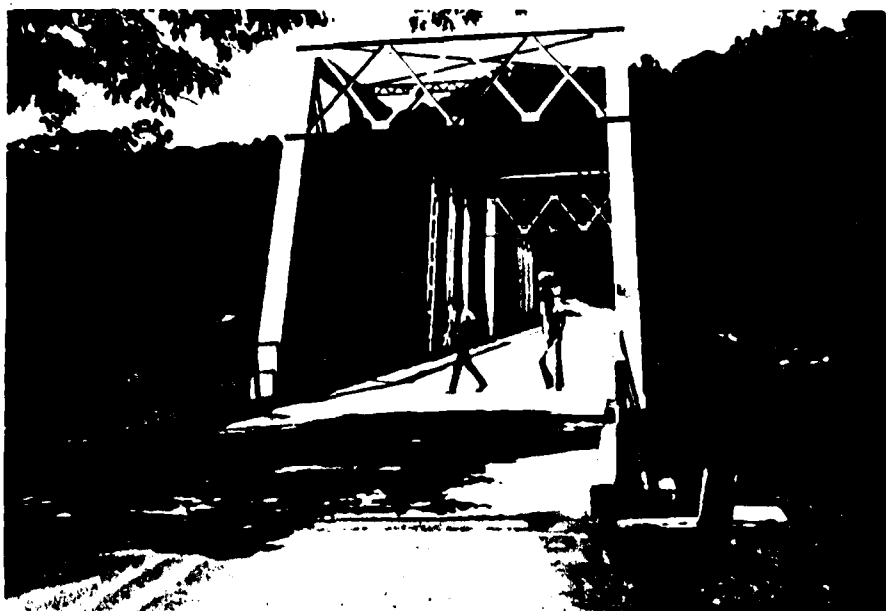
MD. ROUTE 623  
BRIDGE 1 MILE DOWNSTREAM
